ALLEGHENY RIVER BASIN

CONEWANGO CREEK WATERSHED PROJECT SITE 19

CATTARAUGUS COUNTY, NEW YORK

PHASE 1 INSPECTION REPORT 6 NATIONAL DAM SAFETY PROGRAM.

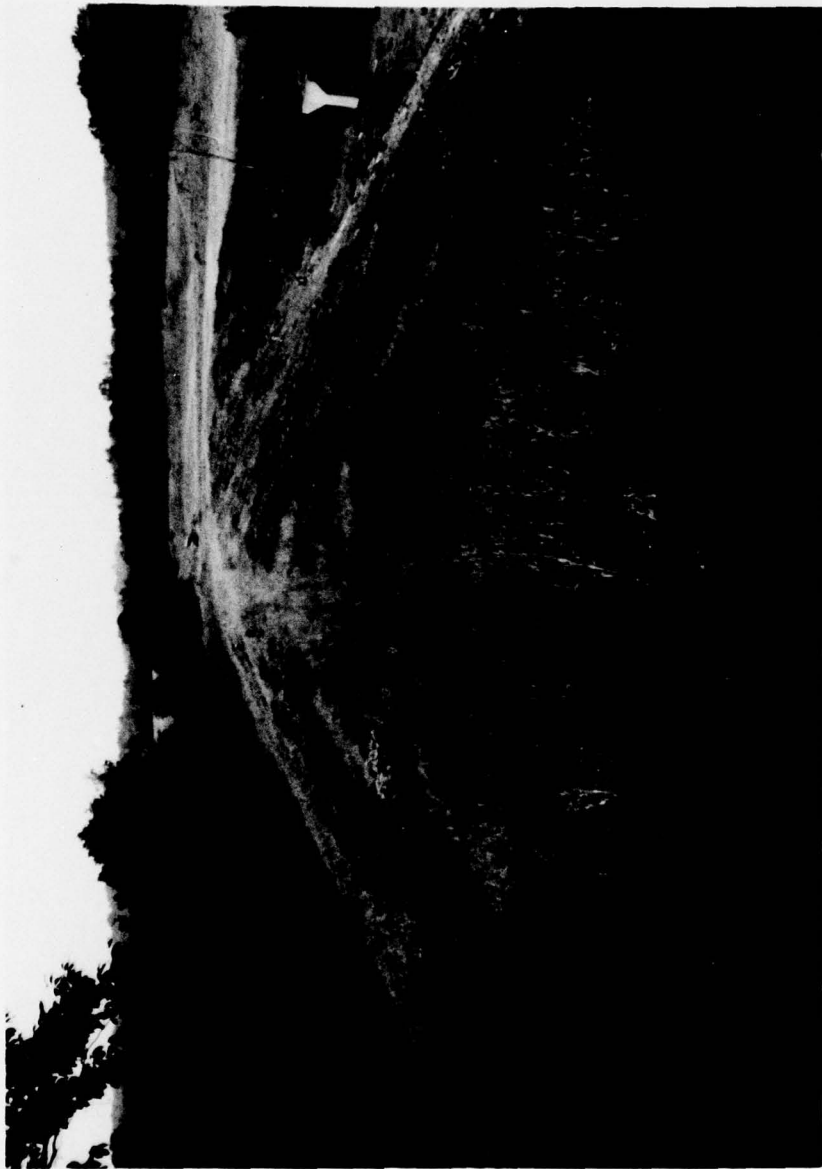
Overview of Conewango Creek Watershed Project Site 19 Dam
Photo #1

No signs of distress were observed on the crest or slopes of the earth embankment (See photos #1 & 2). However, the following conditions were noted at the left (north) abutment contact:

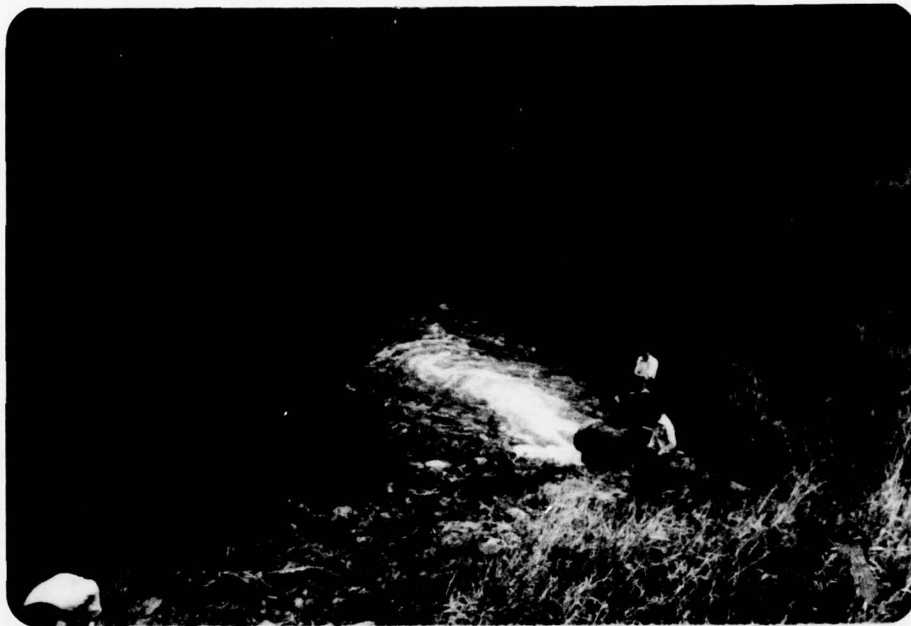
The principal spillway consists of a vertical drop inlet structure, a reinforced concrete pipe founded on bedrock, and a plunge pool (See photos #4, 5 & 6). These components appear to be satisfactory with the exception of debris from a recent storm on top of the riser and the constricted outlet of the plunge pool.

Plunge Pool
Photo #5

d. Condition of Tail race channel exit of plunge pool constructed so that
blow backup into internal drain pipes

- b. Repair the eroded area of the left abutment above the crest of the dam.
- c. Remove the rock outcrops at the outlet of the plunge pool to prevent backing-up of plunge pool outflow, and clean the debris and soil which has accumulated in the internal drainpipes.

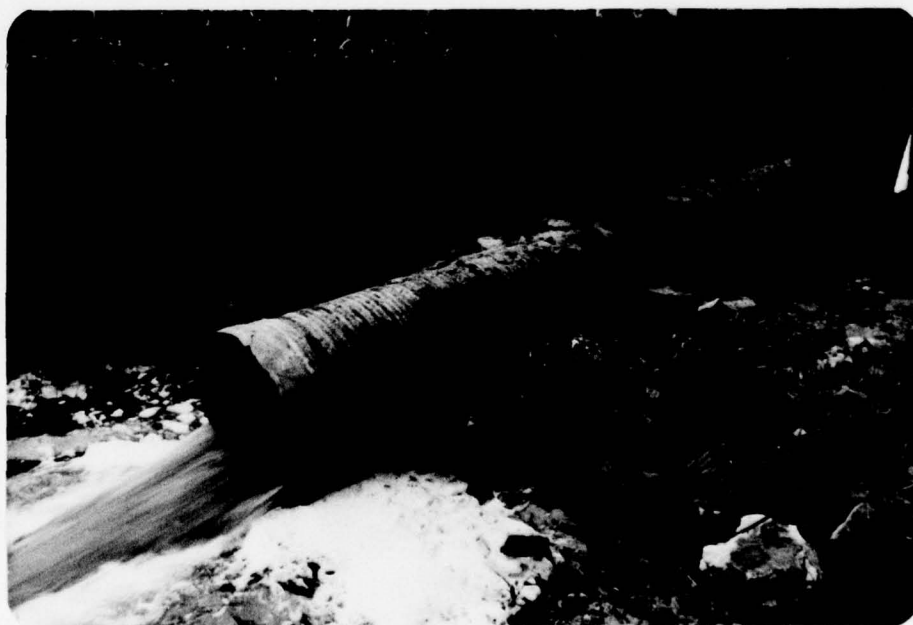
Outlet of Principal Spillway Conduit
Photo #6

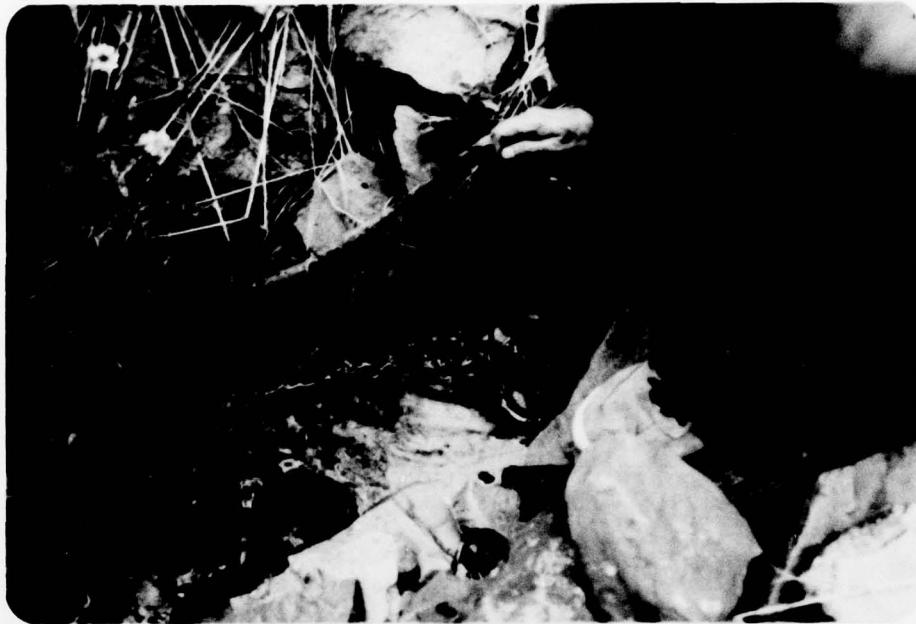
Right Internal Drain
Photo #7

right pipe: surging water 1-2 gpm rusty color
no fine migration; cycle of surge 2 to 5 seconds
flow stops completely then flows fully again

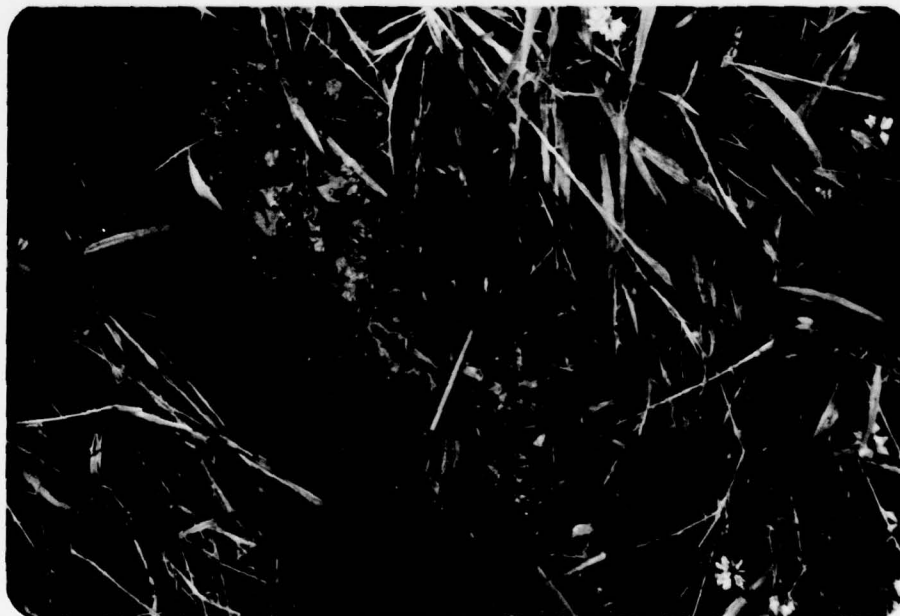
Point #2: Located approximately 2 feet below Point #1; flow was noted emerging vertically from beneath a rock, flow rate 2 to 5 gpm (See photo #12);

Seepage Point #2
Photo #12

1. Investigate the observed seepage at the toe of the dam to ascertain the extent and type of remedial action required;
2. Investigate the erosion of the left abutment contact on the downstream face and initiate repairs to prevent further erosion;

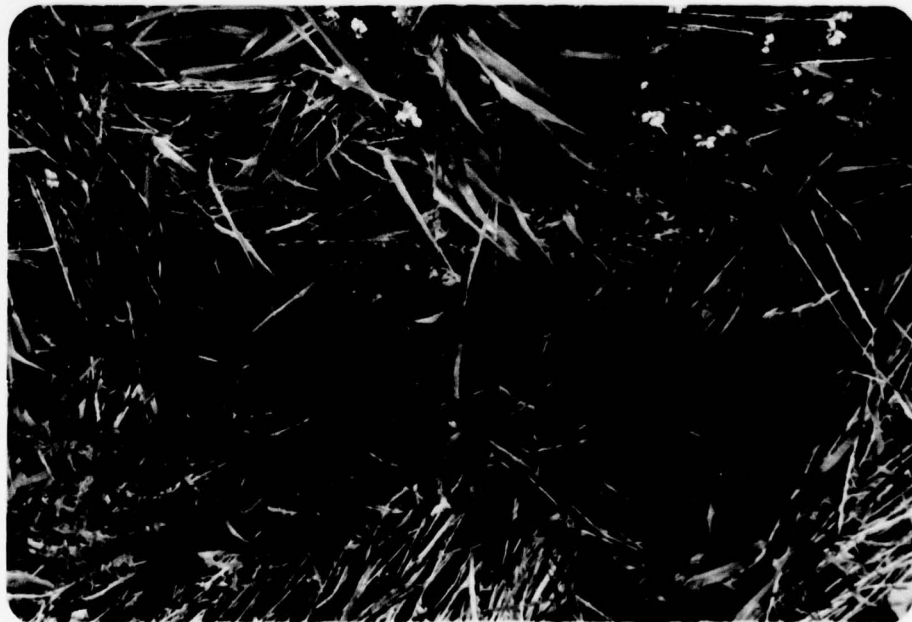
1. Three seepage points were observed near the toe of the dam at the left abutment contact (See photo #11):

Seepage Points #1 & 2
Photo #13
